THE
GREAT EARTHQUAKE
OF JAPAN

1891.

BY
JOHN MILNE.
AND
W.K. BURTON.
PLATES BY K. OGAWA.

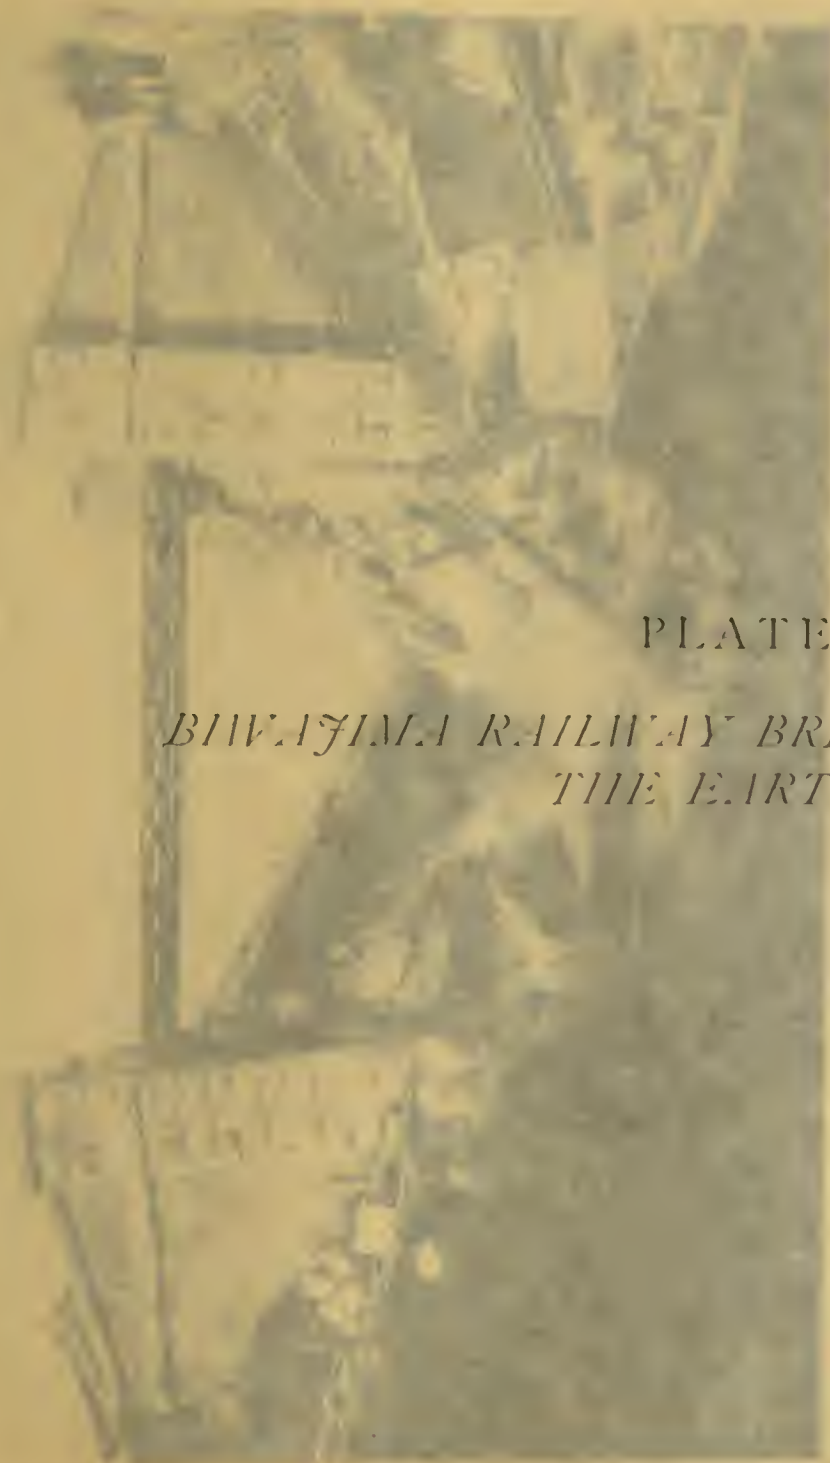
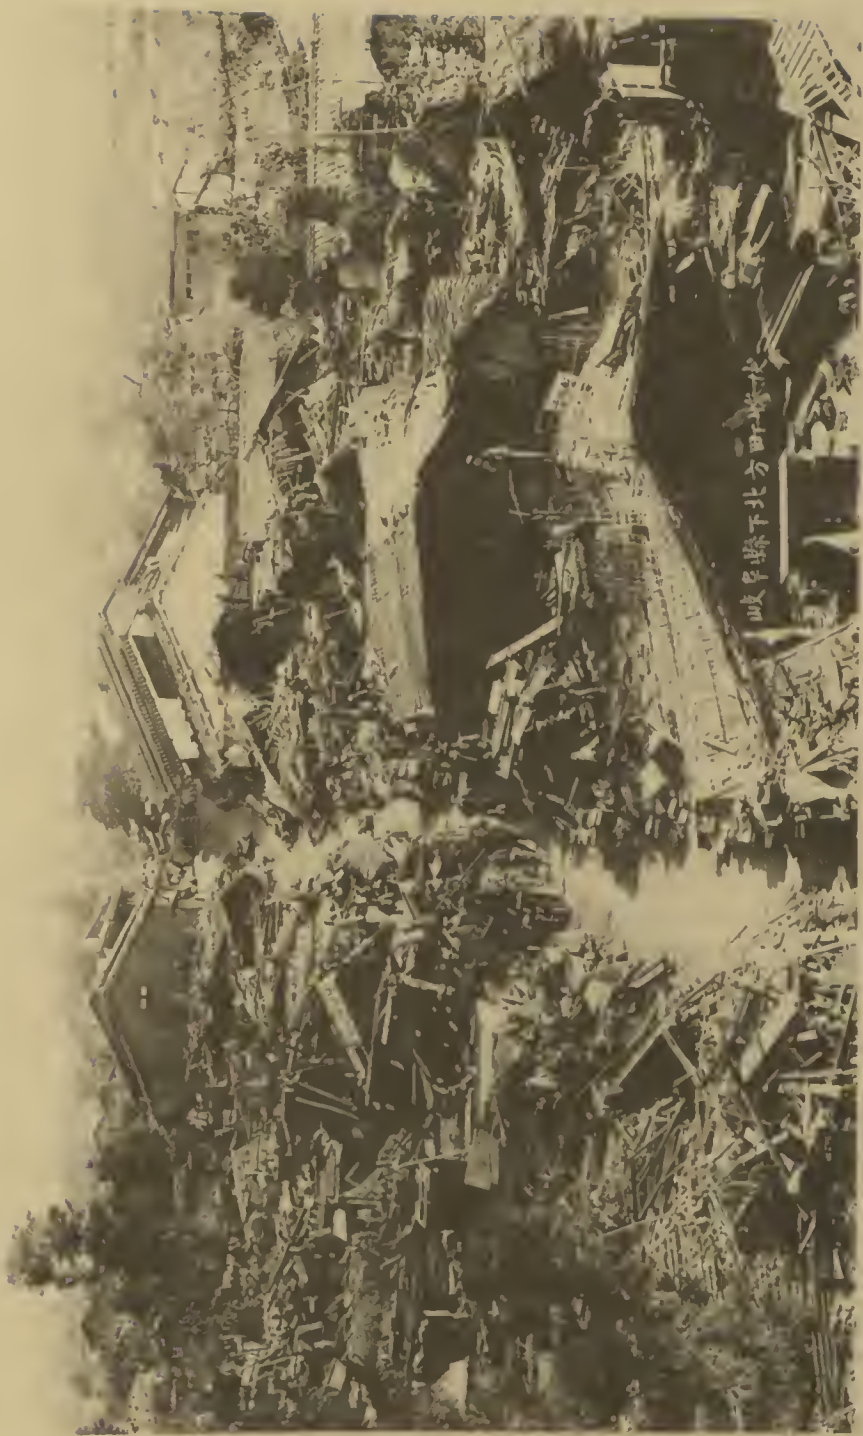
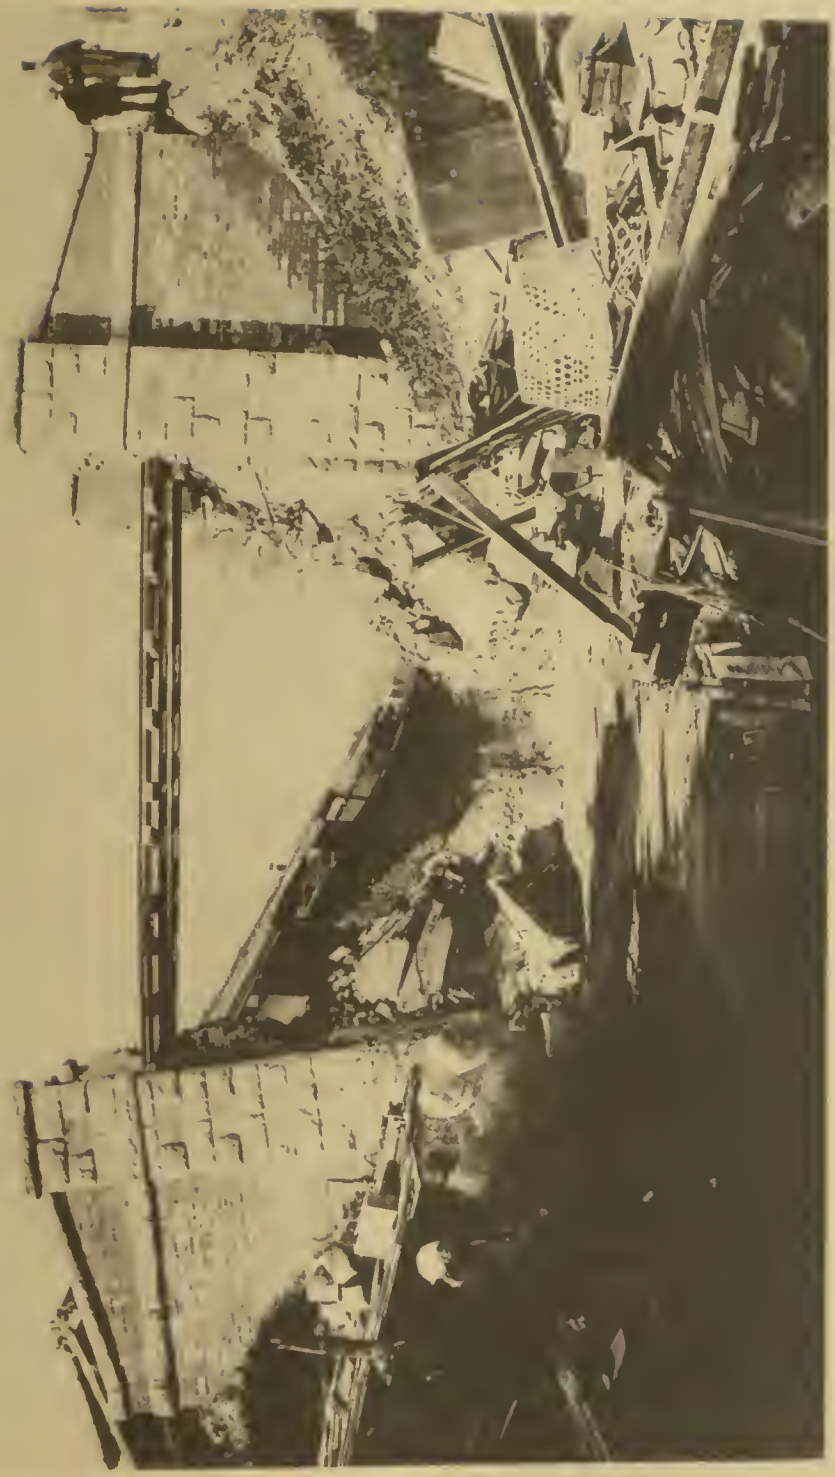
PLATE XII.

*BIWAJIMA RAILWAY BRIDGE AND GIFU AFTER
THE EARTHQUAKE.*

One explanation of this disaster is that the embankments to the right and left first gave way and the thrust, due to the weight of the arch as it cracked and sank, acted like a toggle-joint, forcing the abutments backwards.

Whatever the cause may have been, it illustrates the unsuitability of arches to horizontal disturbances, and assists us in understanding the reason why, in several Earthquake countries, ordinary archwork is prohibited.

which are from 15 to 30 feet in height and have a cross-section of 20 feet by 10 feet. Each of these rises from two wells which are arched together at the water-line. It is through this arch, which it must be observed is the lowest part of the piers, where fracture has taken place.

The fracture has therefore been across or through the narrowest dimension of the columns. The lateral shifting of the foundations by which the distances between the piers have been reduced, has been the result of a permanent compression, which had the bridge been represented by a line across the river bed, would have been contorted into one or more snake like bends.

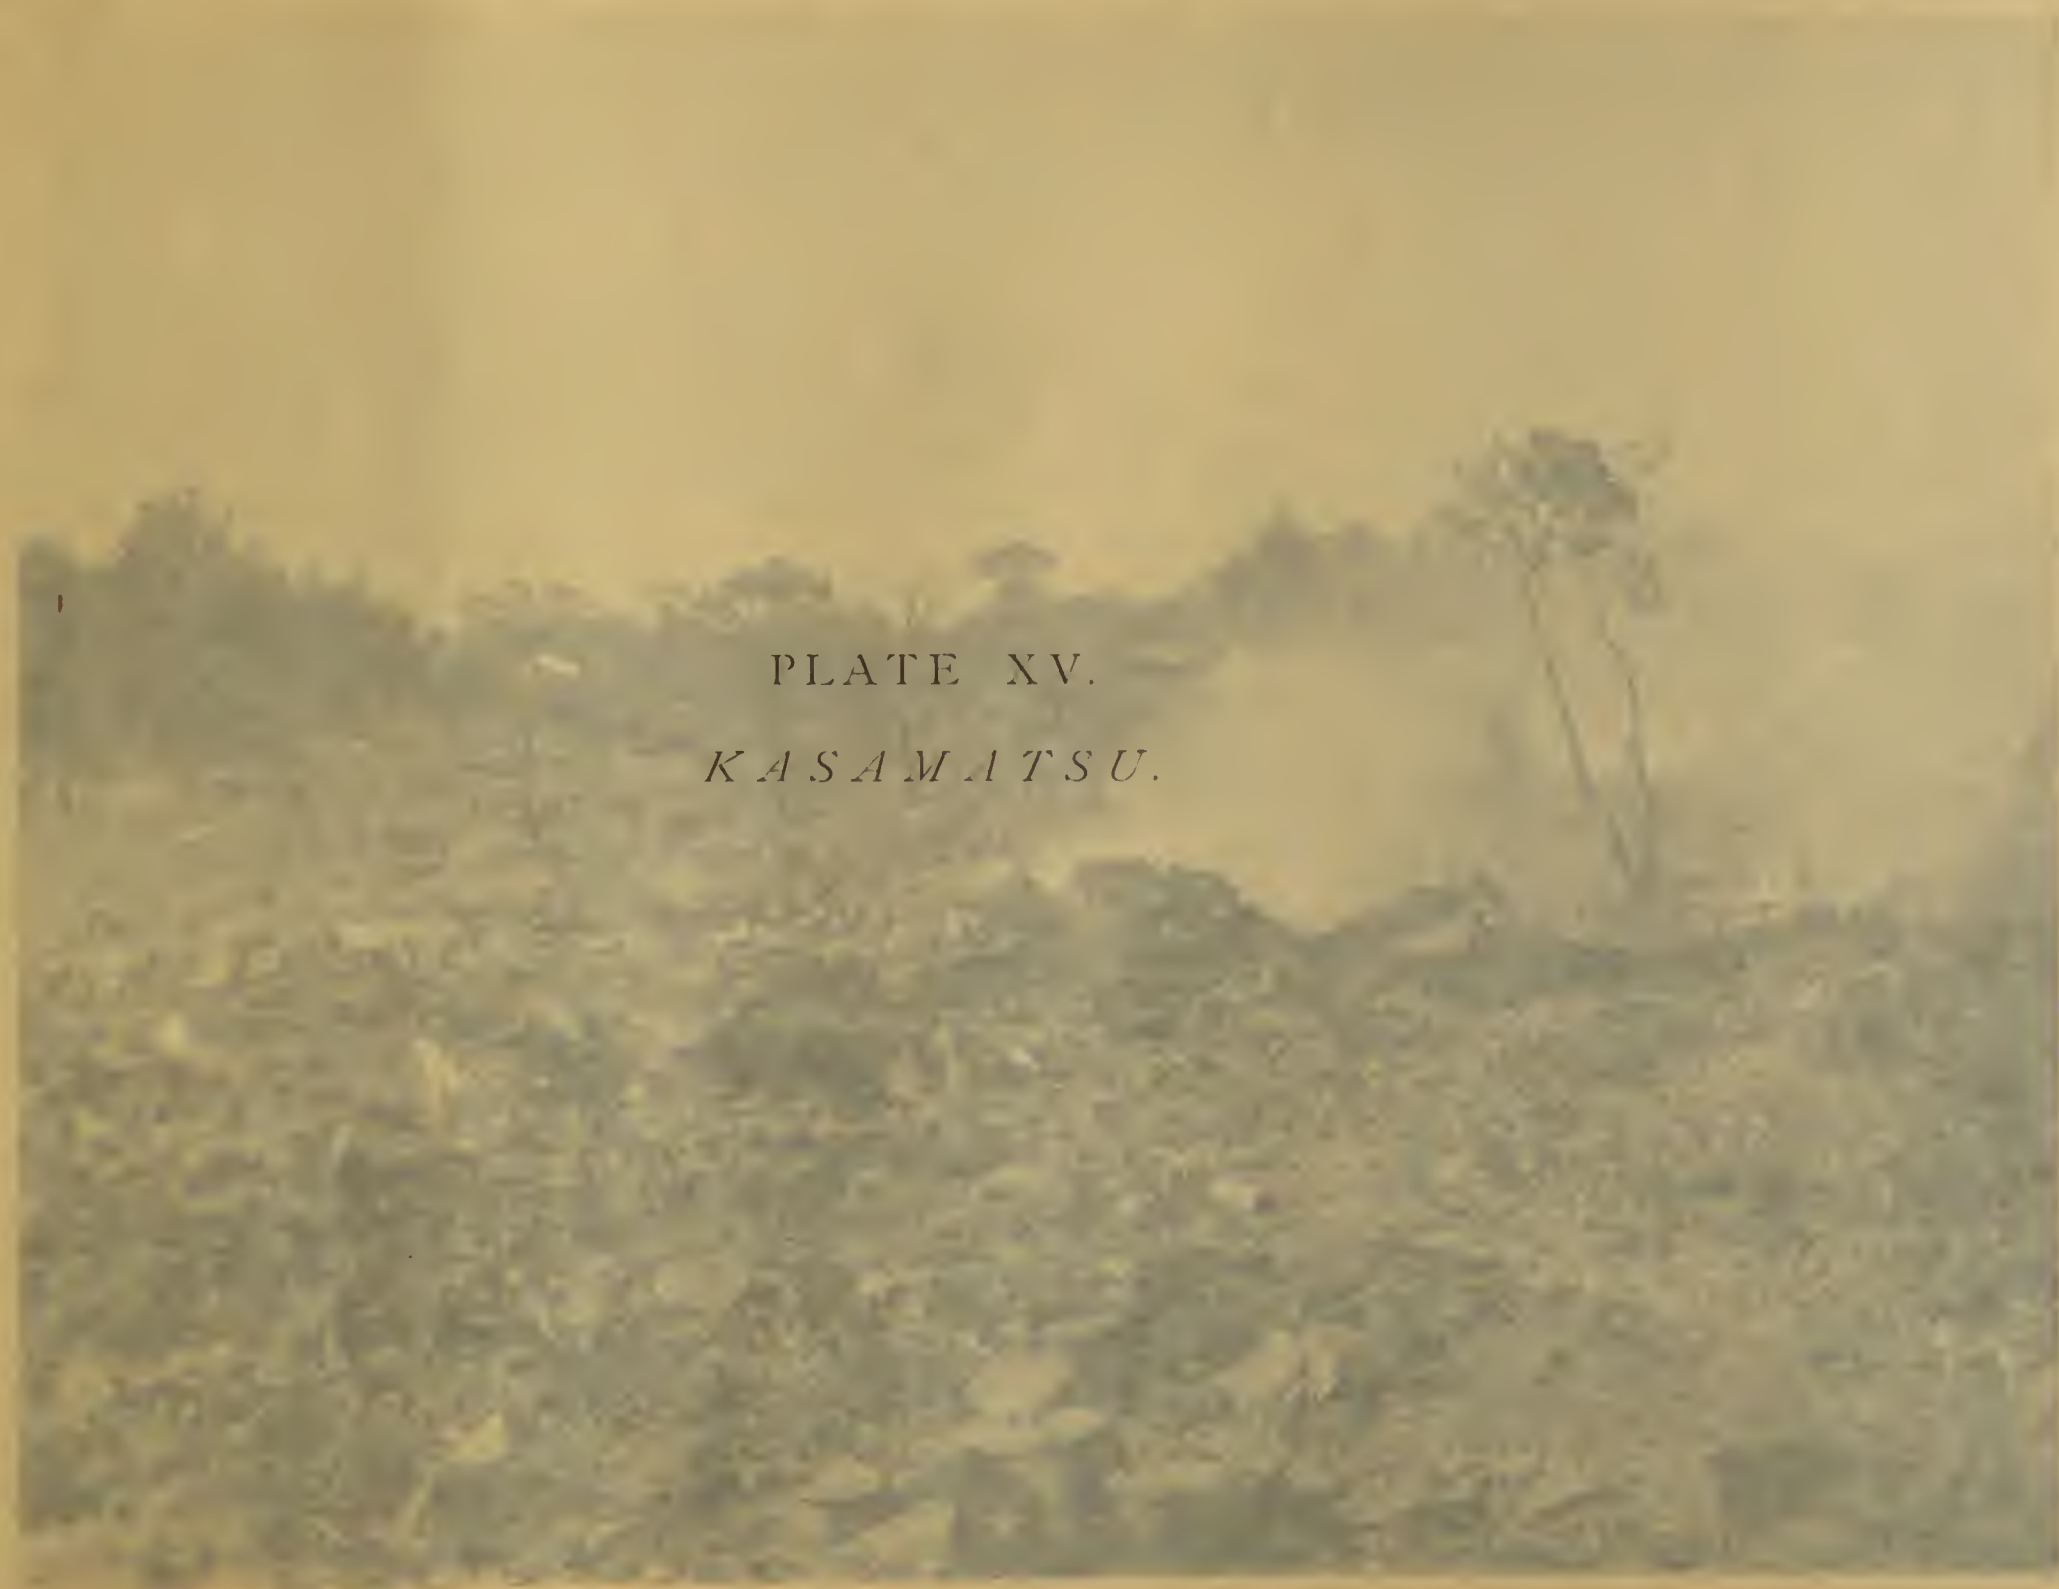
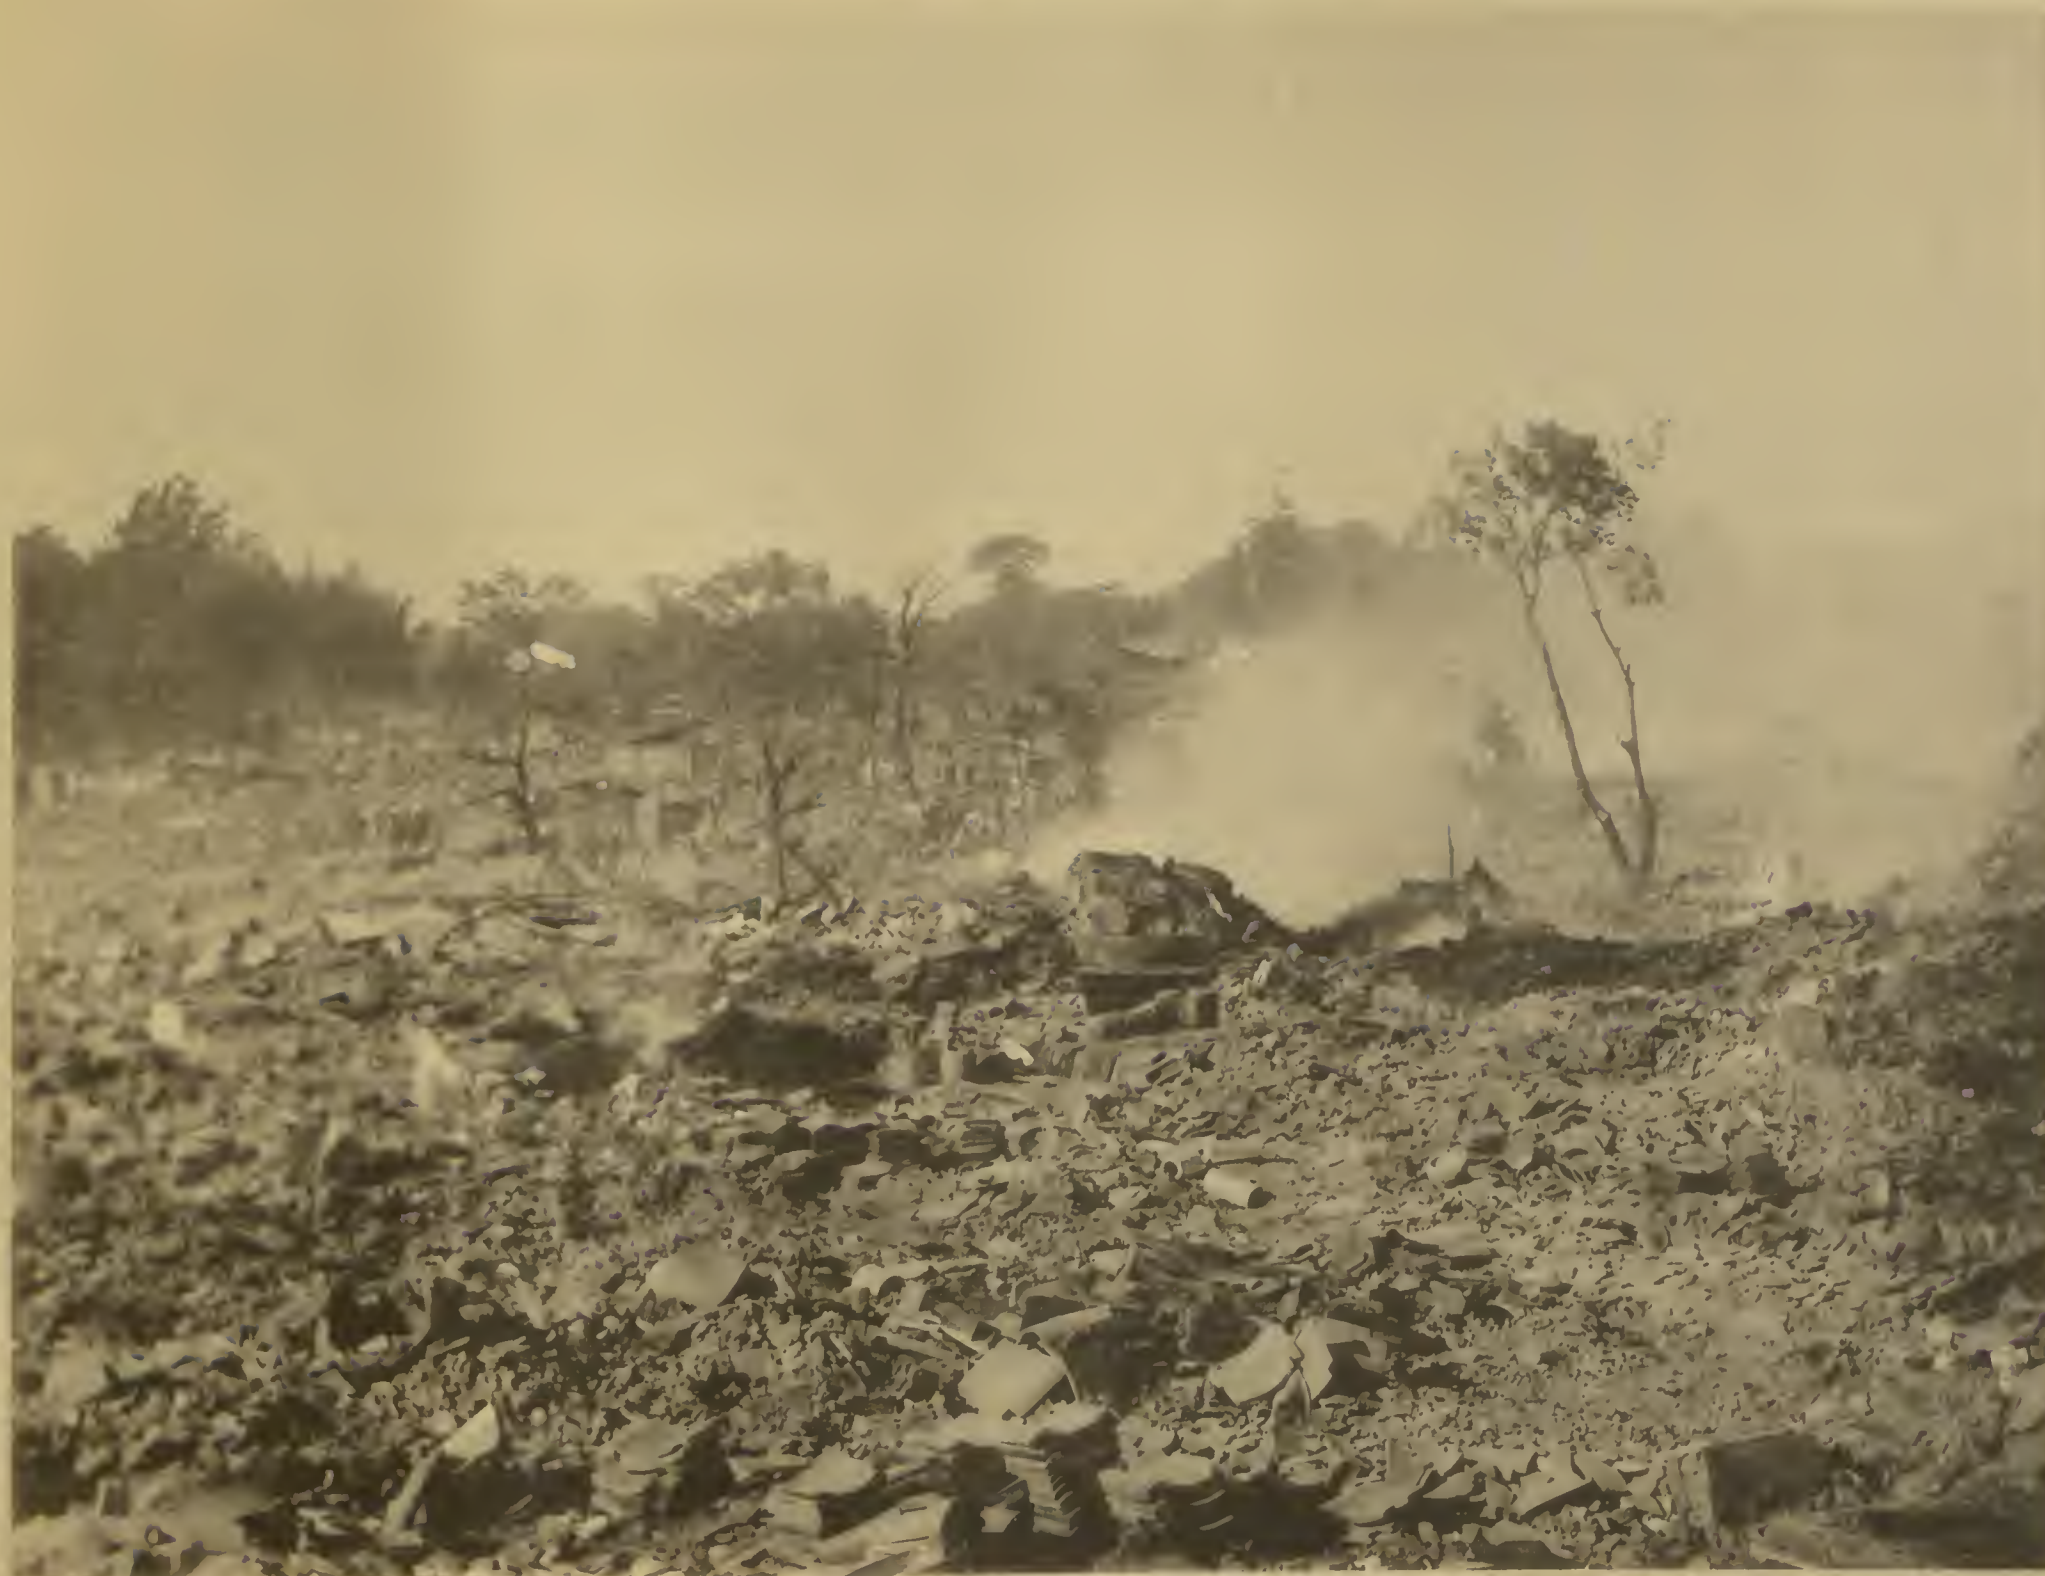
PLATE XV.
KASAMATSU.

HE foot bridge across the Kisogawa at Kasamatsu has simply disappeared, leaving nothing to show where it was. One crosses by boat, to the place where Kasamatsu was, but all that is left of the place is a reddish coloured plain of tiles and other unflammable things, which, when we were there, were still smoking. Fire broke out after the Earthquake, and the town was completely destroyed.

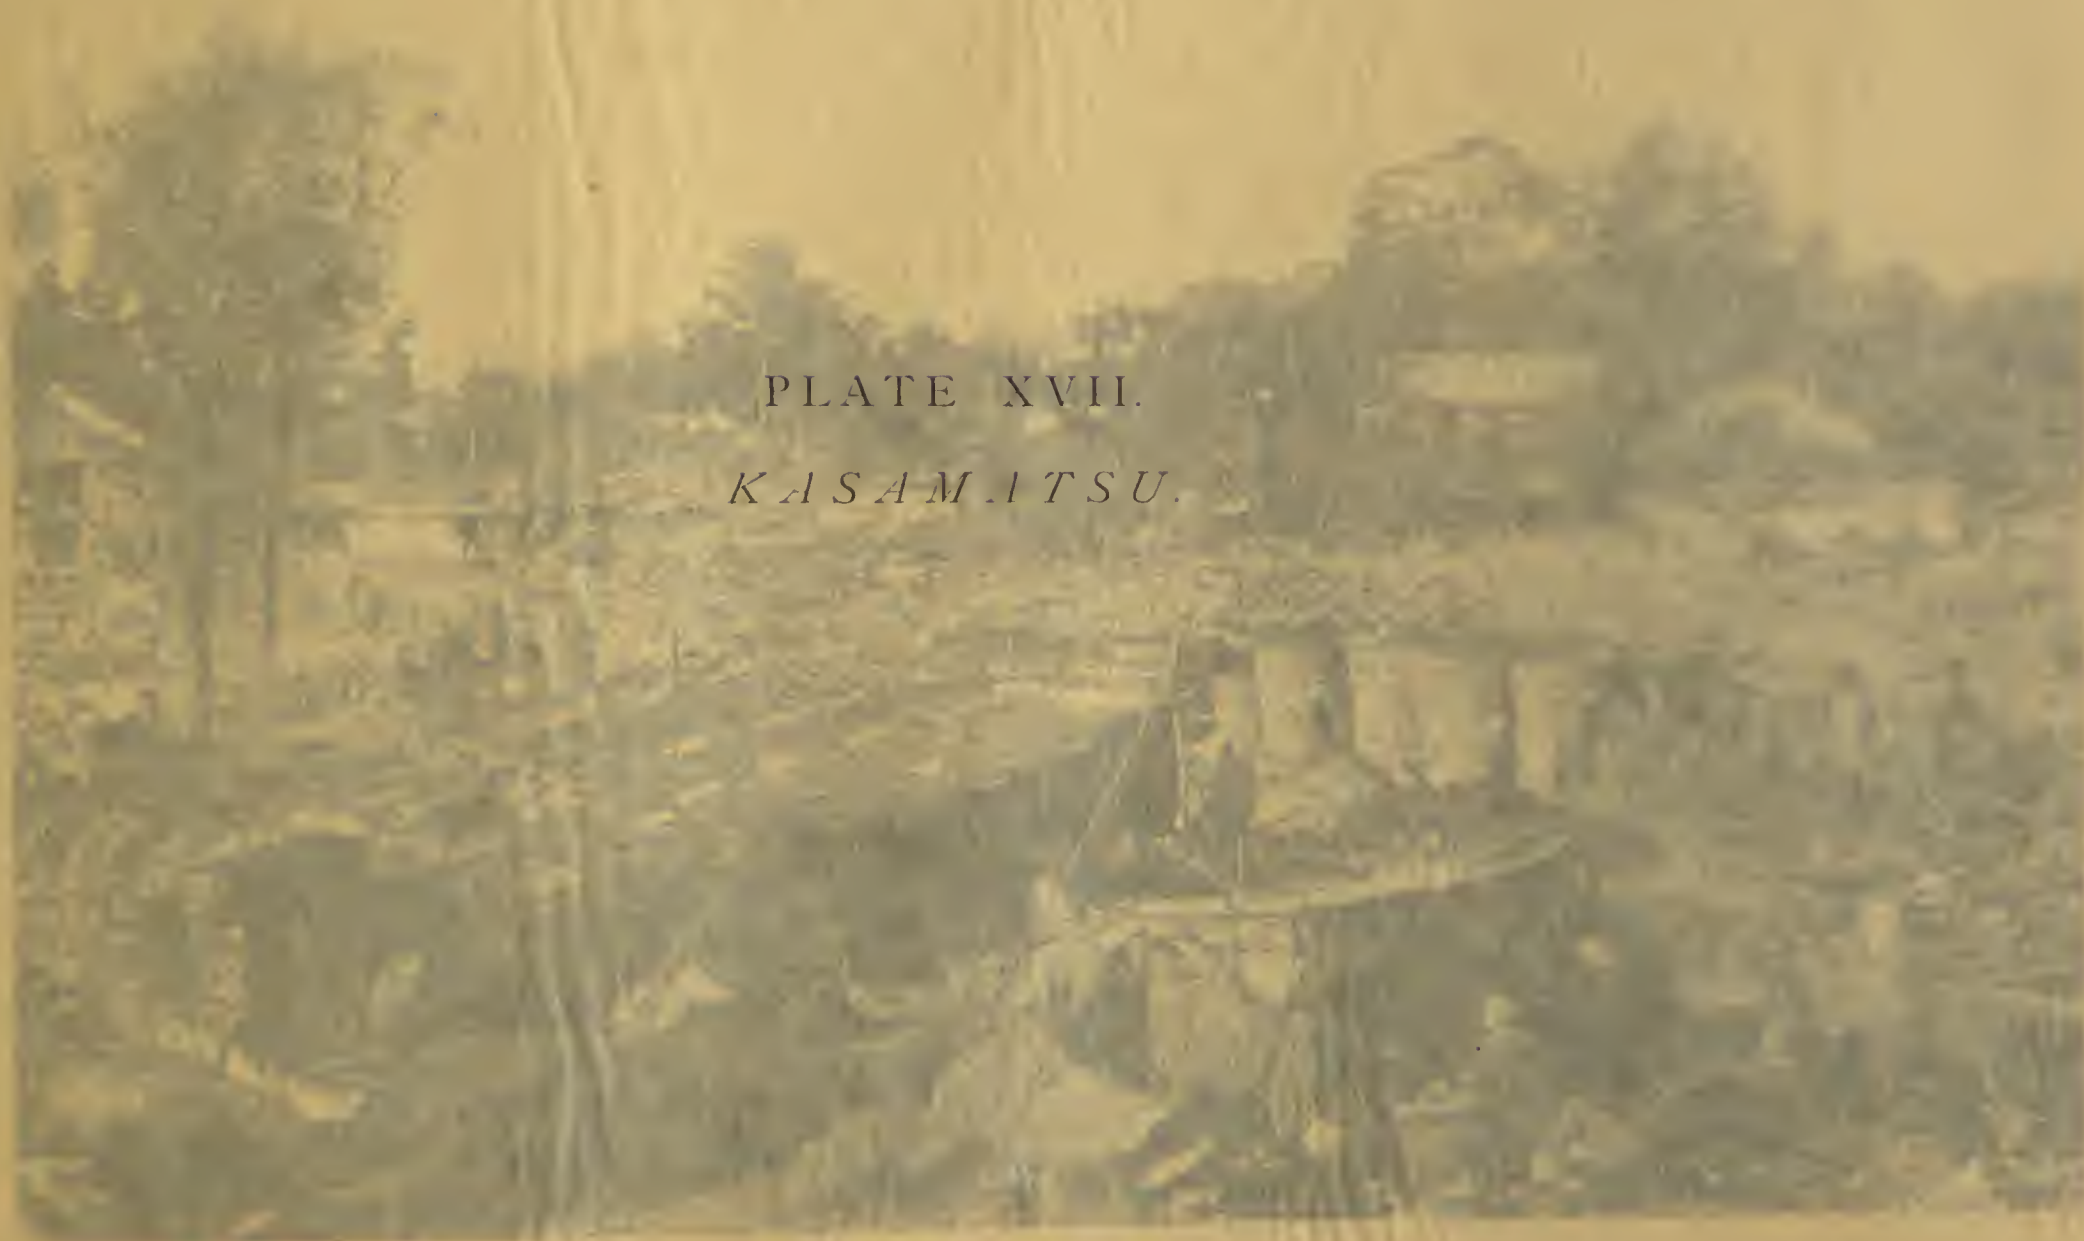
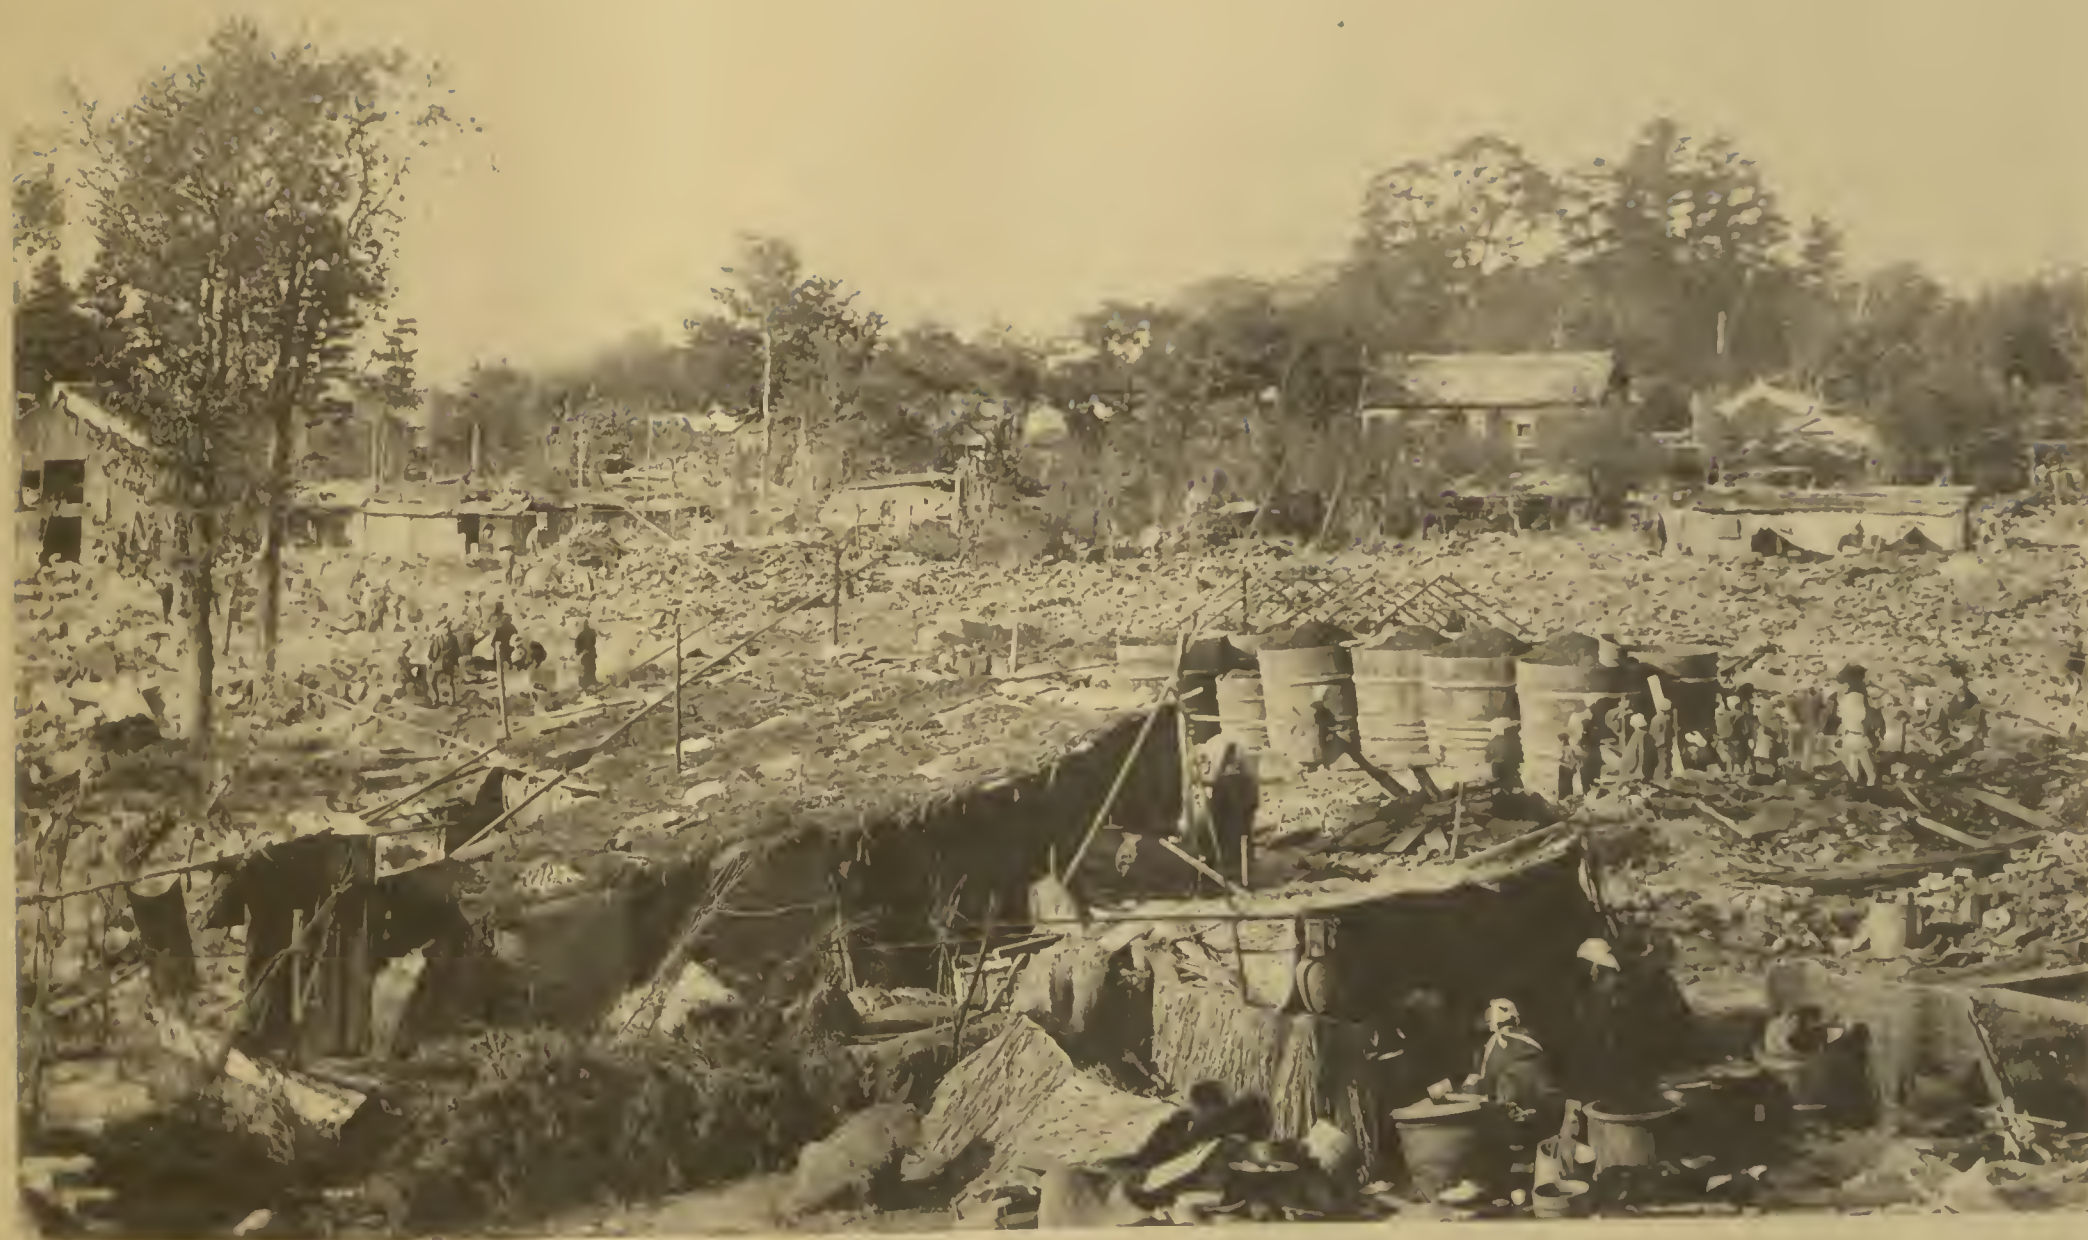
PLATE XVII.
KASAMITSU.

The large wooden tubs in the centre evidently mark the site of a *miso* or *shoyu* (bean sauce) factory. Two *kura* or warehouses, which have heavy roofs and are built of timbers with a wattle of bamboo filled in with mud, have fairly well resisted the motion.

Excepting these warehouses and the trees, everything has been levelled with the plain.

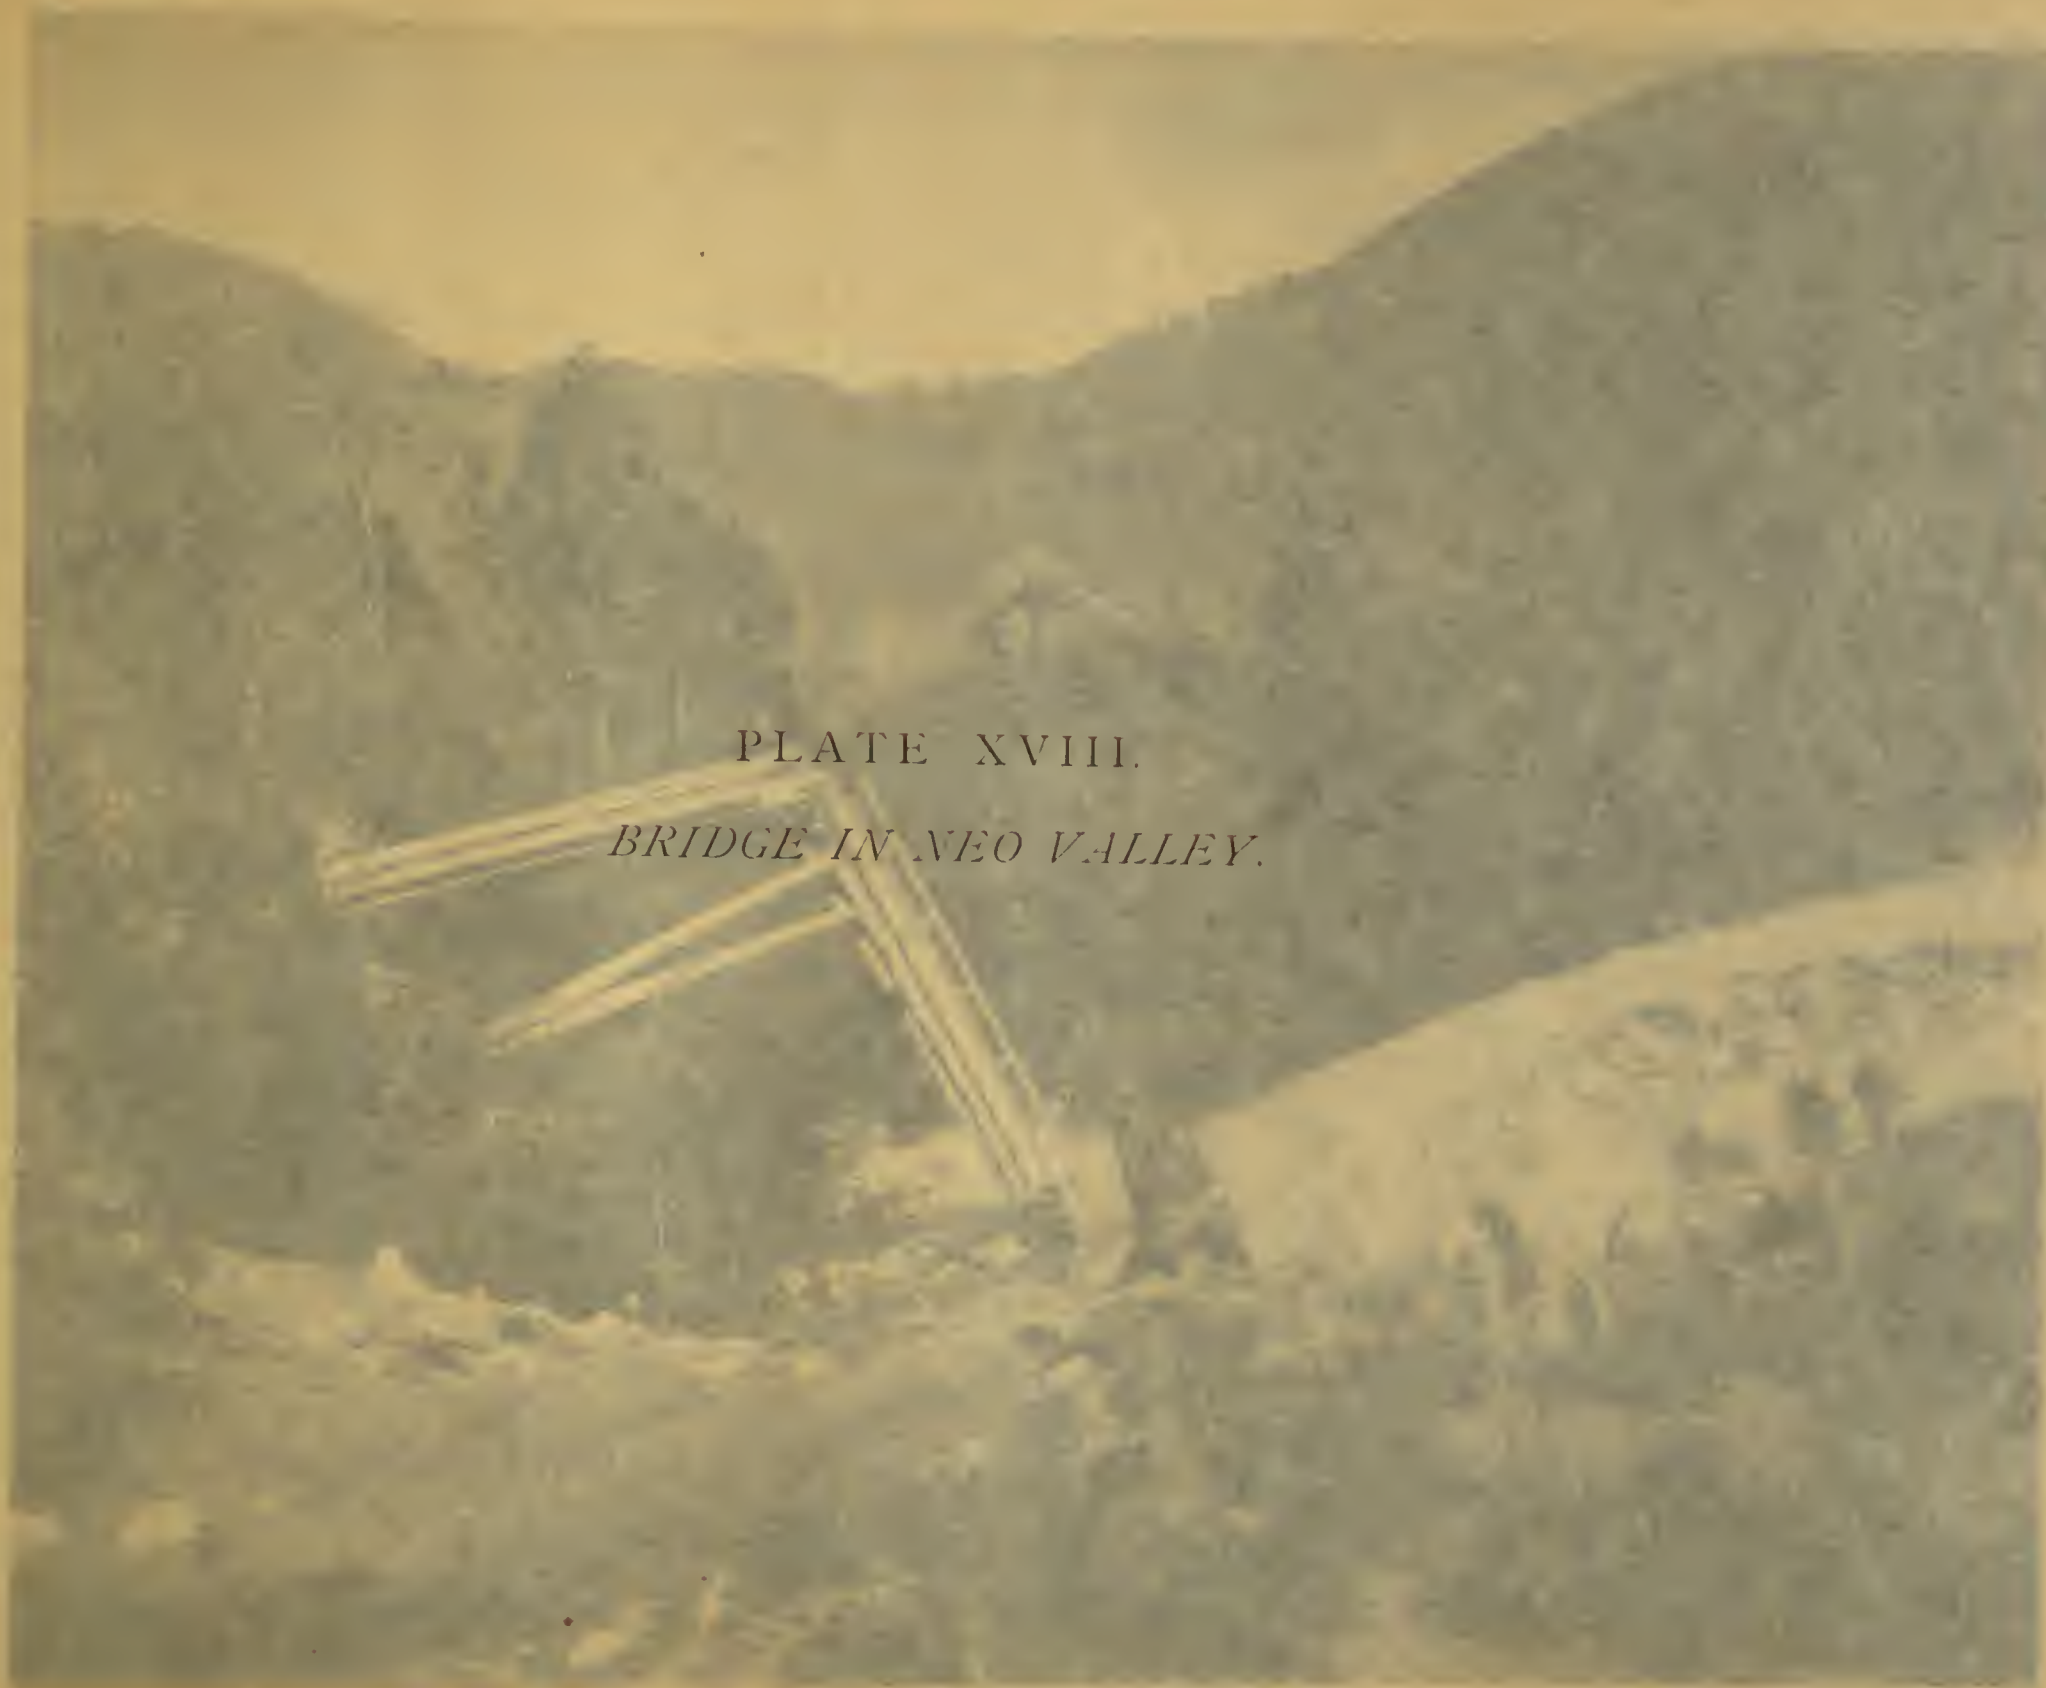
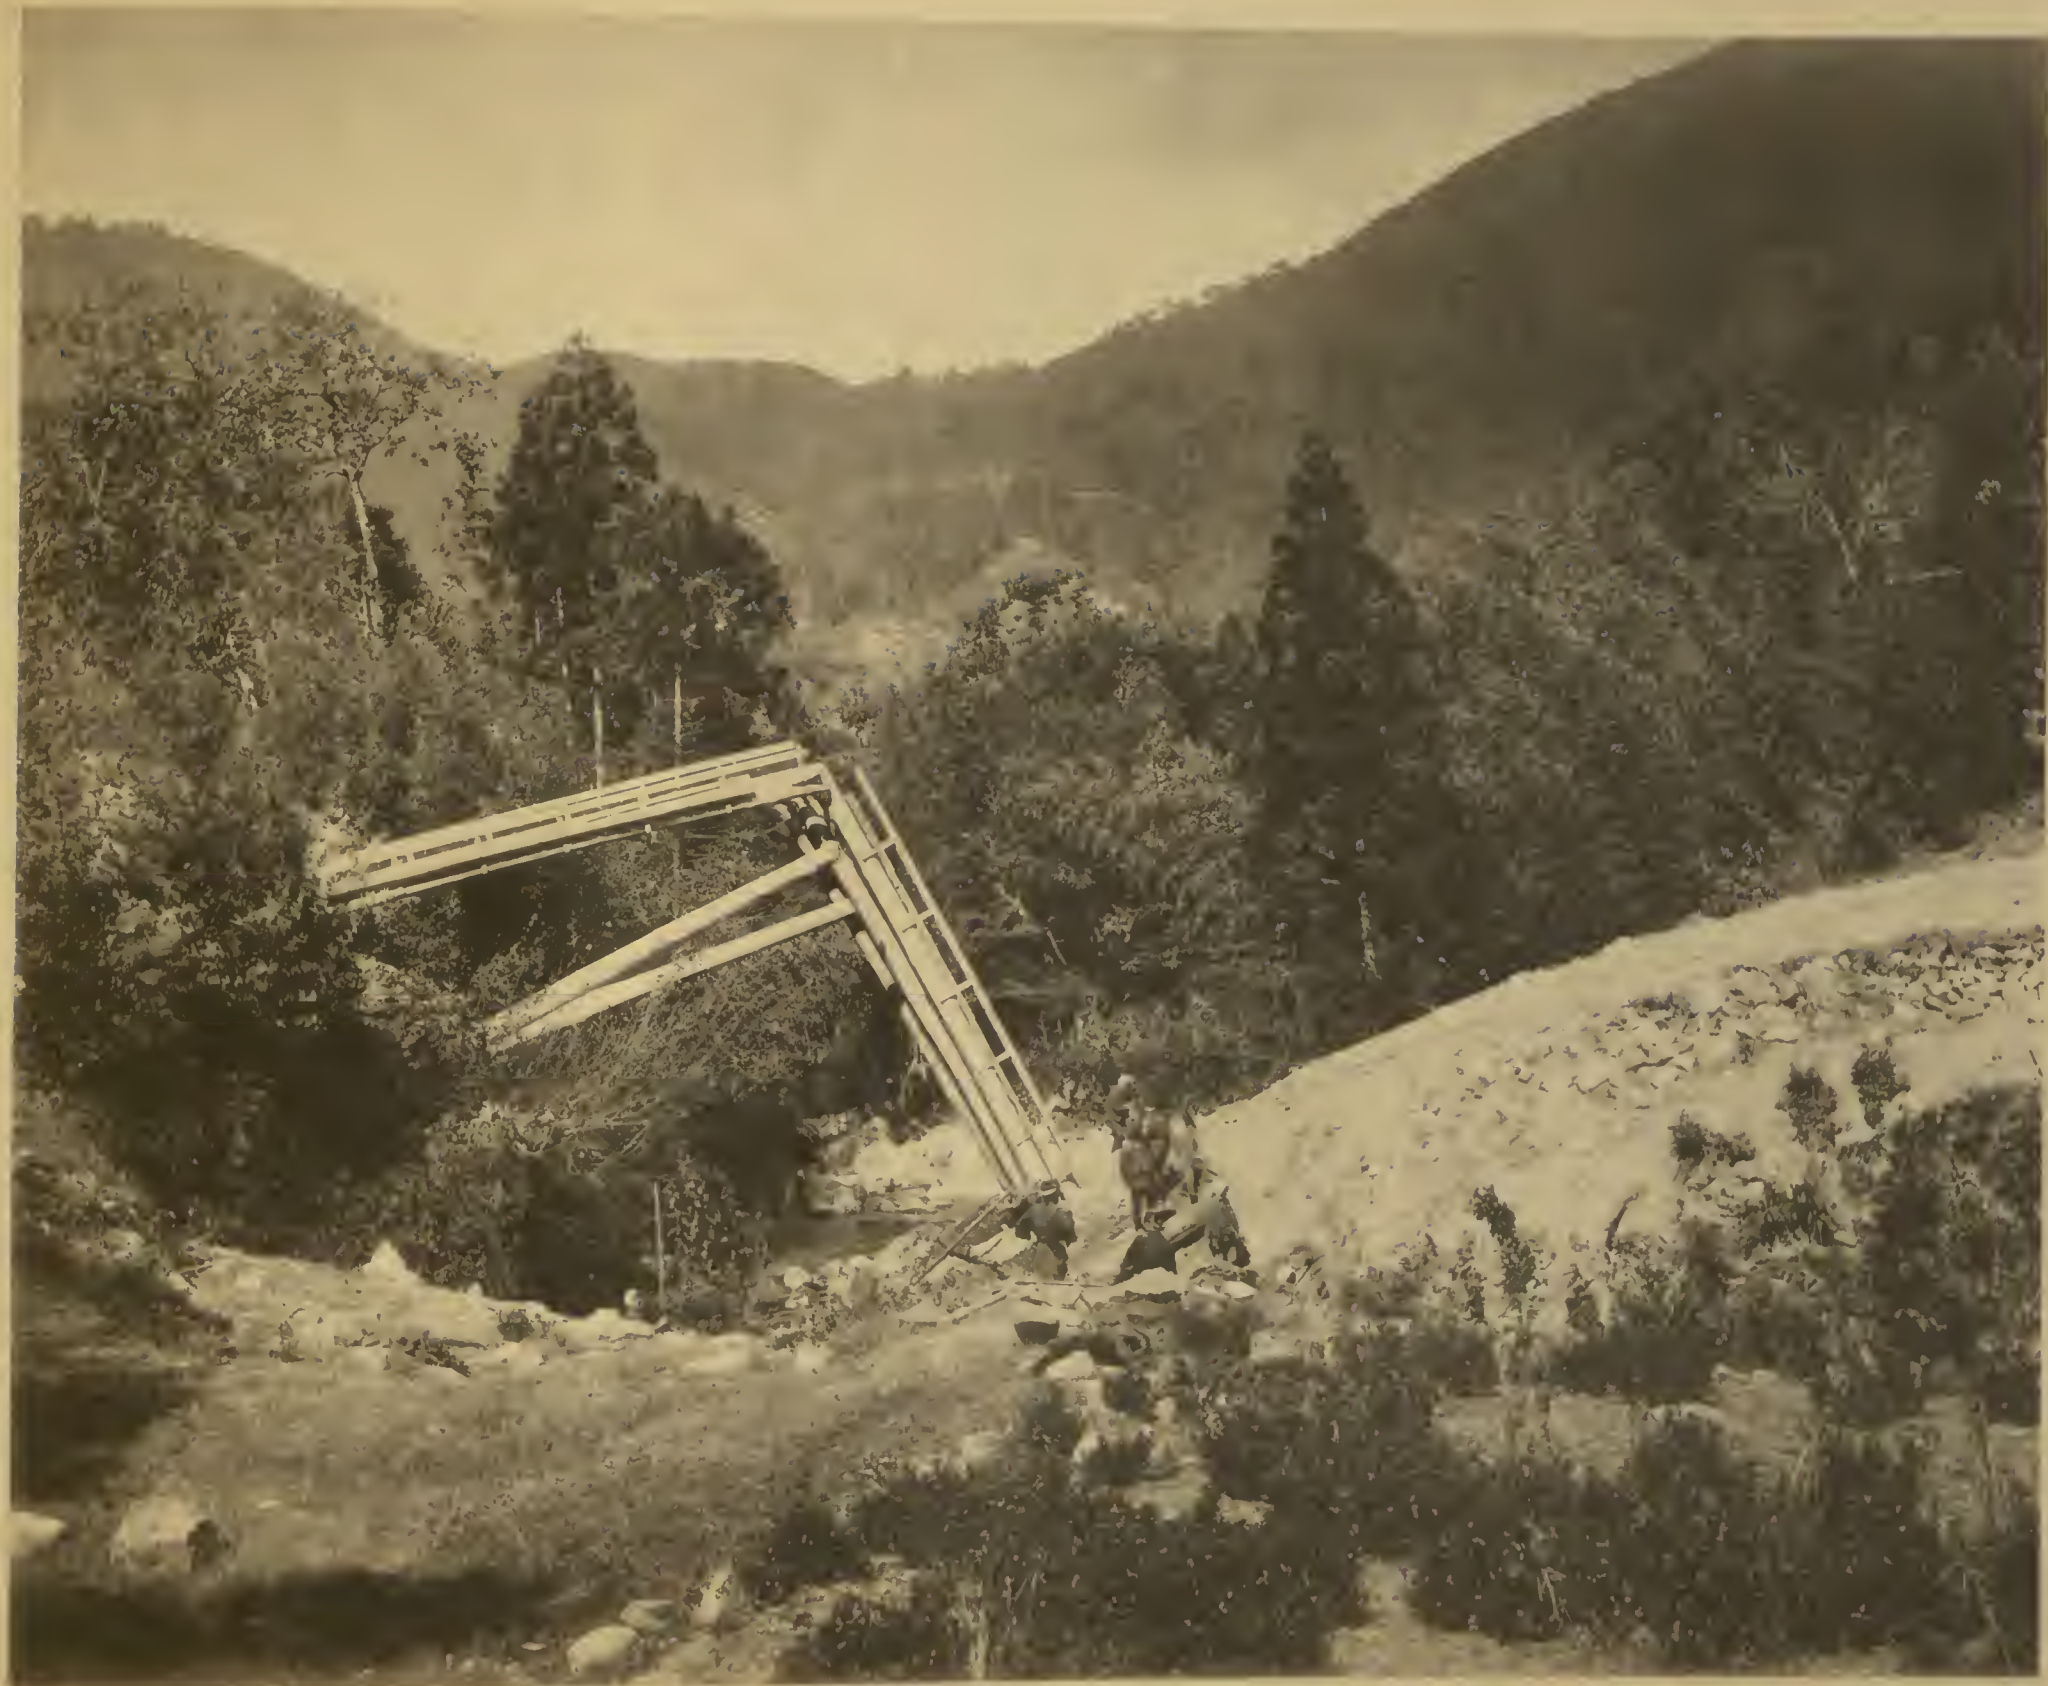
PLATE XVIII.
BRIDGE IN NEO VALLEY.

ERE we have a scene in the famous Neo Valley, where the disturbance was practically at its maximum. In some places the ground has sunk, and at others risen, and the people say that the mountains themselves have been depressed, so that from certain points hills formerly invisible now raise up their heads.

On the left of the picture a portion of a light cantilever bridge remains in position: The frame forming the middle span has fallen downwards, and two of its leg-like supports are seen nearly parallel with the cantilever. Restoring what was the horizontal portion of the bridge to its original position, we see that the second pair of supports, which must have occupied a position in front of the dark *Cryptomeria* standing amongst bamboo, in the background, and the right hand cantilever, have been swept away, the ground having either sunk, or been spread right and left by the violence of the shaking.
